PHASE I INSPECTION REPORT
NATIONAL DAM SAFETY PROGRAM

17. DISTRIBUTION: National Dam Safety Program. Wanaksink Lake Dam, Delaware River Basin, Sullivan County, New York. Phase I Inspection Report. (Inventory Number NY 330)

PHASE 1 INSPECTION REPORT
NATIONAL DAM SAFETY PROGRAM
WANAKSINK LAKE DAM I.D. No. NY 330
DEC #195 DELAWARE RIVER BASIN
SULLIVAN COUNTY
(FORMERLY LORDS RESERVOIR DAM)

Date of Inspection: November 15, 1978

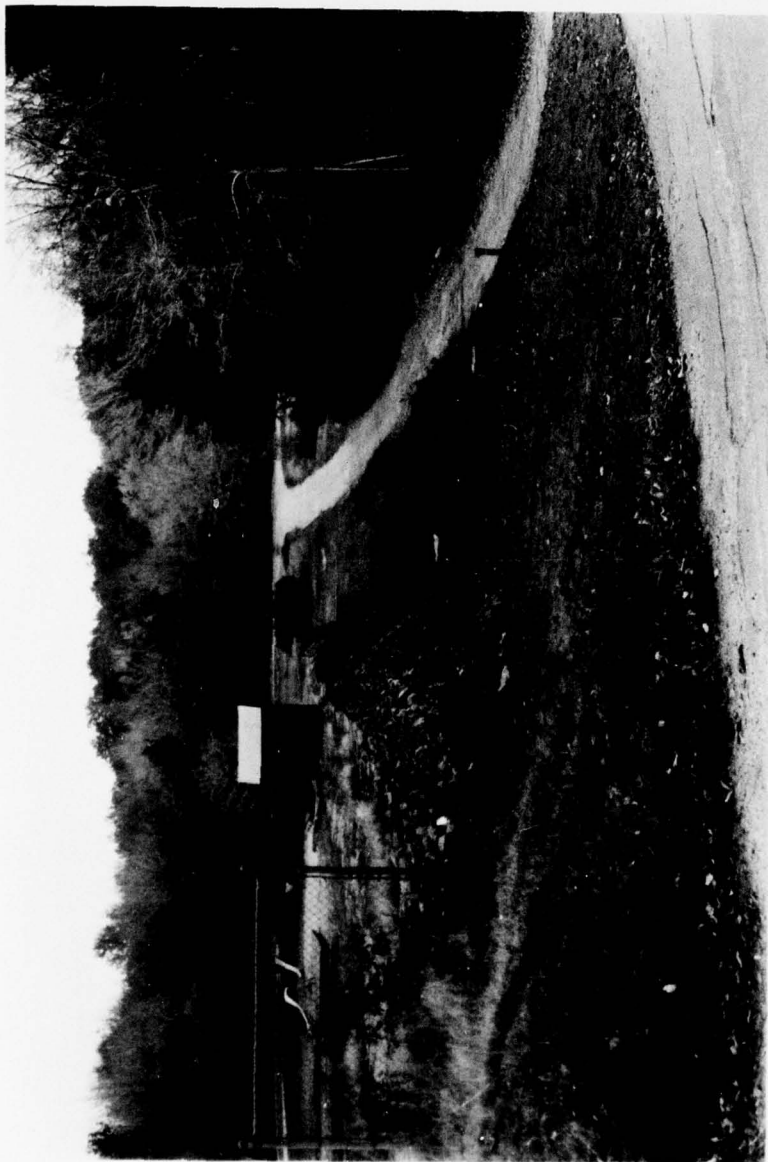
Overview of Wanaksink Lake Dam
Downstream Face

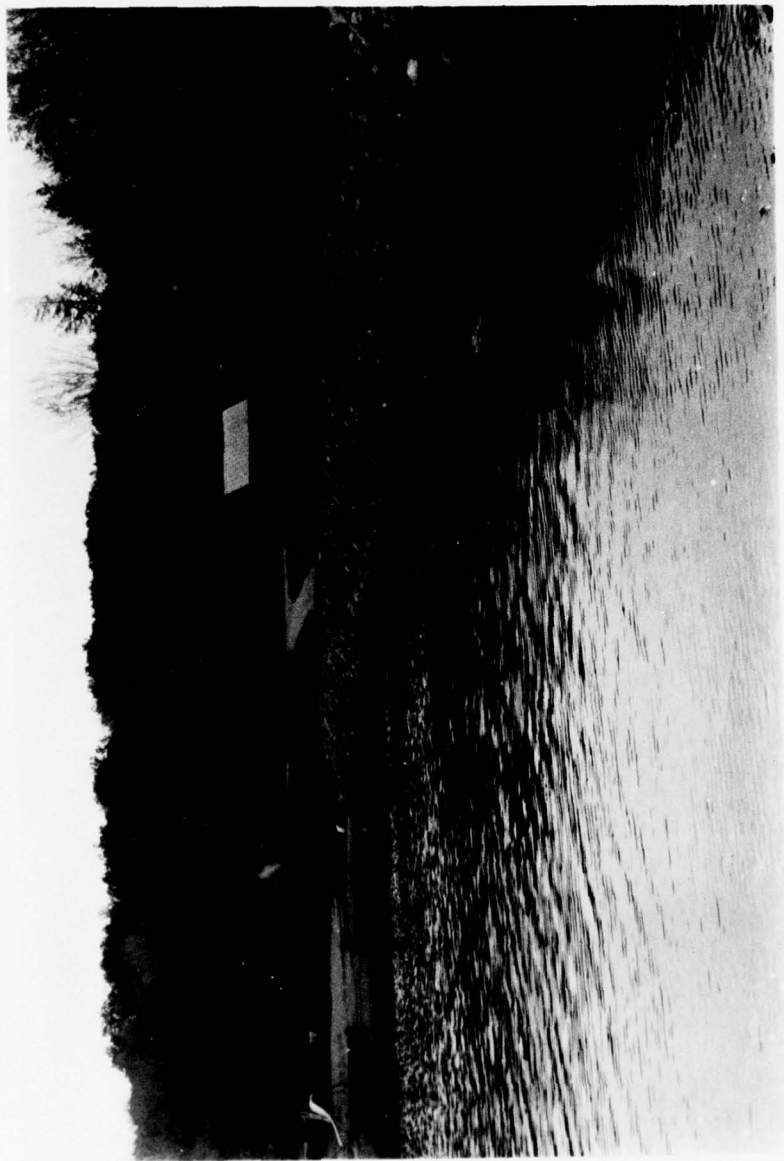
Overview of Wanaksink Lake Dam
Upstream Face

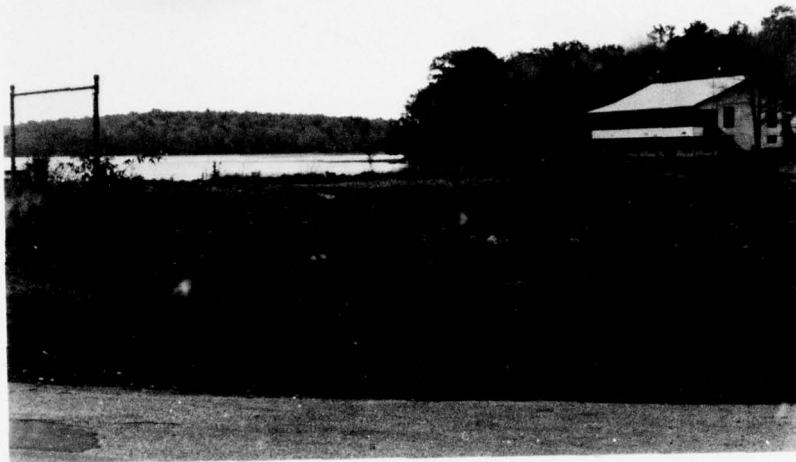
PHOTO #1

North Abutment, Downstream Face

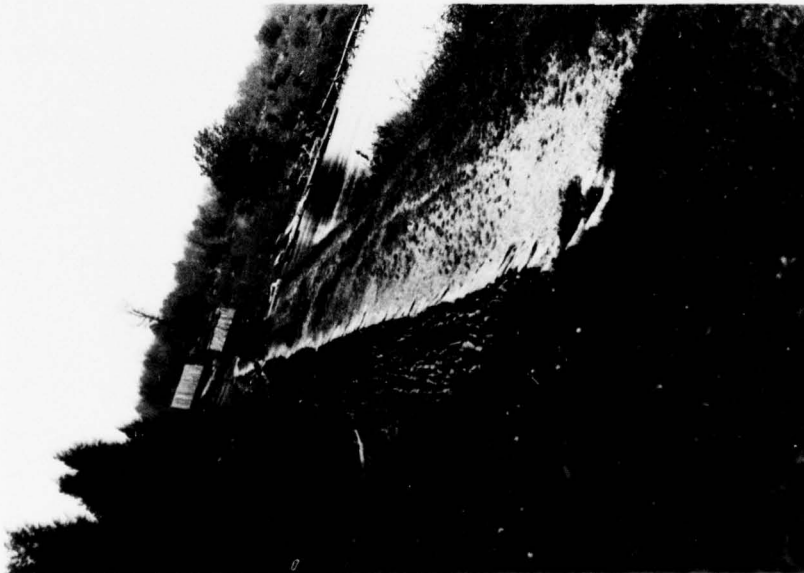
PHOTO #6

Old Photograph of Dam (5-31-13)
Looking North

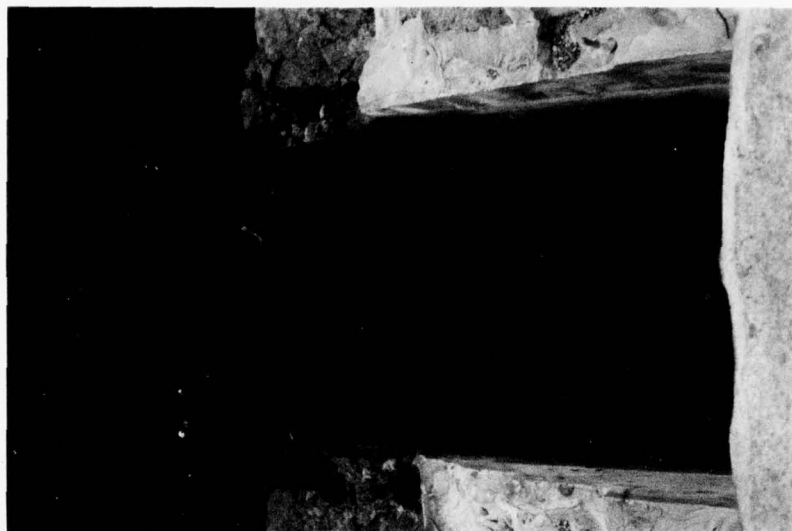
PHOTO #5

Spillway Channel
Looking Upstream from Crest

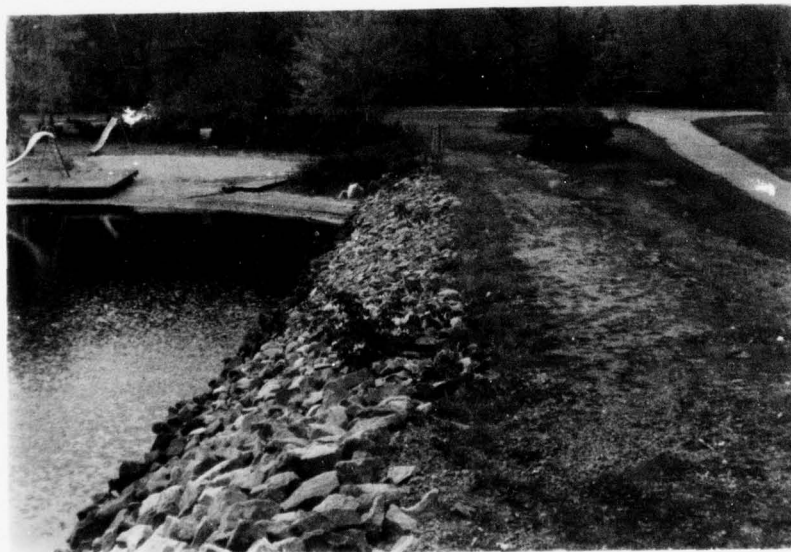
PHOTO #8

Crest and Upstream Face
Looking South from Spillway
